DOMESTIC BUILDING ASSESSMENT REPORT

Section 480, Domestic Building Contracts Act 1995

DBDRV-2017-6-1436

29 Stones Rd DEREEL VIC 3352

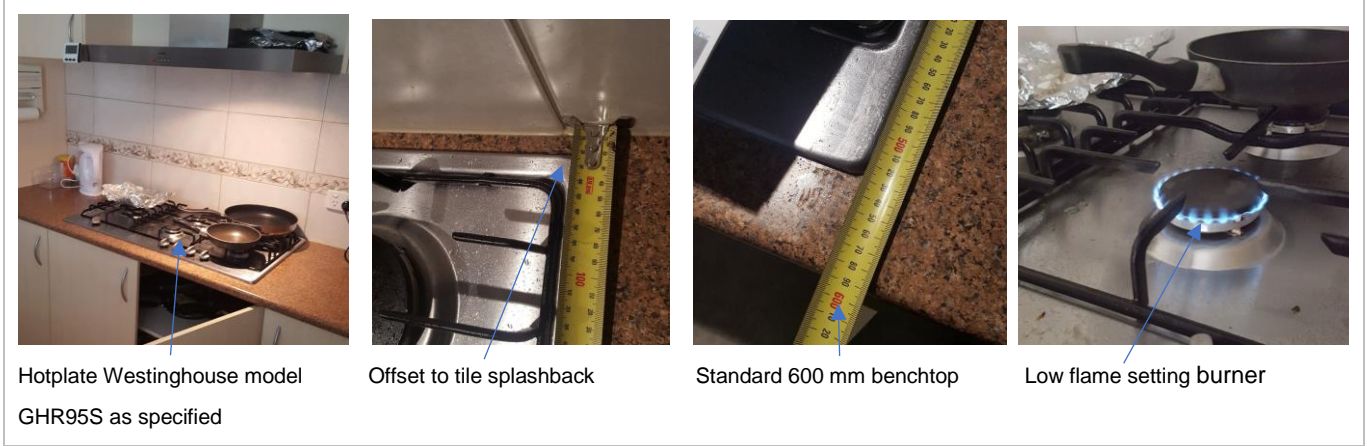
Item one: Cook top is mounted incorrectly. The rear edge is only 2 cm from the wall, while the front edge is 6 cm from the edge of the work surface. The distance between the main burner (rear right) and the wall is inadequate. The “low” setting on all flames is far too high

Cook top mounted incorrectly

2. The assessment revealed that the size of the Westinghouse model GHR95S cook top base only allows for 20 mm offset to the rear splashback wall in a standard 600 mm benchtop.
3. The standard requires that if a burner is positioned within 200 mm from the wall, the wall must be non-combustible surface. As the wall behind the cook top is a non-combustible tiled surface, the item is not defective.

Flame Control

4. Flame control for the gas burners appeared normal at the time of assessment.
5. Therefore this item is not defective.

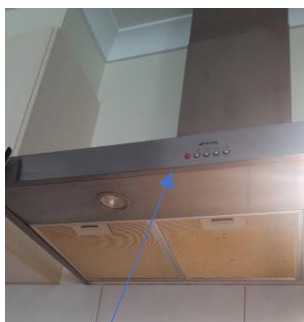
Smeg model K181X9-90

Item two: The range hood is rated at a net air flow of only 590 m³/h. A home measurement was done by the Owner and the output is approximately 110 m³/h, or about 20% of the advertised rate.

1. A visual assessment was carried out of the rangehood located in the kitchen.
2. The assessment revealed that the rangehood was operating as intended by the manufacturer.
3. In accordance with the *Guide* fittings are defective if they do not operate as intended by the manufacturer during the maintenance period of three months after hand over.
4. The assessment was carried out in December 2017 and the hand over date was April 2015, therefore the range hood is also outside the maintenance period.
5. As the range hood is operating as intended by the manufacture and is outside the maintenance period the item is not defective.

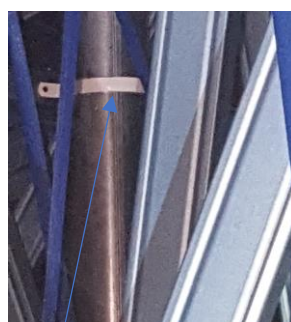
Flue through roof was correct

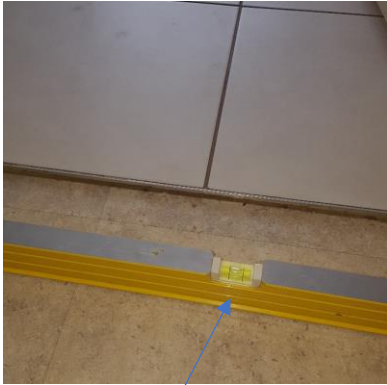
1. A visual assessment was carried out of the doorways to wet areas.
2. The assessment revealed that the difference between the vinyl and tiles was measured as 9 mm.
3. This is within the normal range for different floor finishes and less than the maximum step allowed at a door threshold to the Code.

Item three: The floor levels are different between the bathrooms and laundry, where the floors are tiled with ceramic tiles, and the rest of the house, which is covered with vinyl tiles. There is a difference in the floor level of 9 mm (the vinyl floors are lower).

Vinyl to tile level

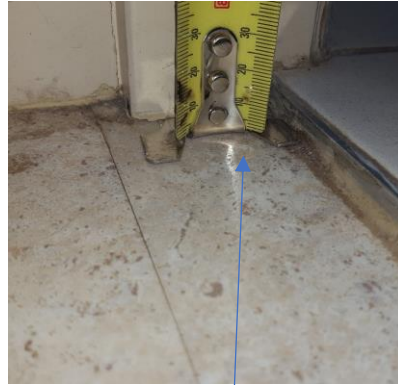
Level difference 9 mm

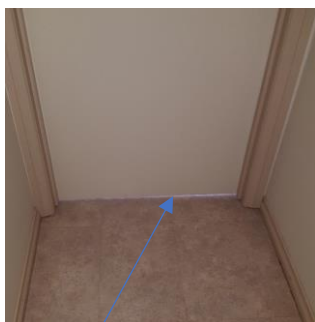
Item four: *The floor is uneven, with differences of up to 5 mm. The gap under the door of the main bedroom is several millimetres higher on the right than on the left.*

Gap under doors

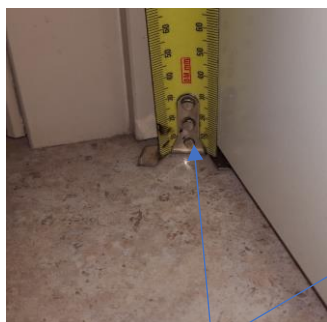
Approx. 4 mm difference across doors measured

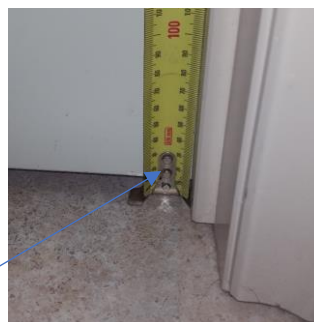
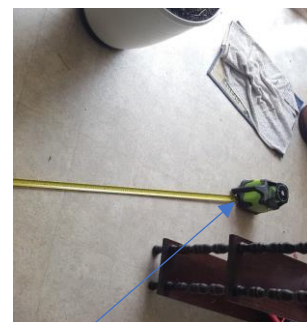
Laser level Dining floor

1. A visual assessment was carried out of the floor levels to bedroom door, Dining & Living floors.
2. The assessment revealed that when an automatic levelling laser level was applied to the Dining Living floor and the levels were within 4 mm of each other in any 2000 mm direction. Within the whole area there was a difference of up to 5 mm.
3. Under doors a difference was noted of up to 4 mm side to side.
4. In accordance with the *Guide*, floors must not differ by more than 10 mm in any room or area. Therefore the item is not defective.

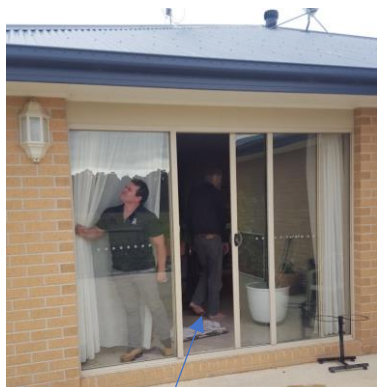
Dining sliding door unit

Item five: The contract provides for double glazing throughout, but the windows with sliding doors are all single-glazed, a total of 4 window panels and 3 glass sliding doors.

1. A visual assessment was carried out of the sliding door located in the Dining Living.
2. The assessment revealed that the glazing to the sliding doors was single glazed Low E glass as required on the contract document drawings and energy report.
3. Therefore this item is not defective.

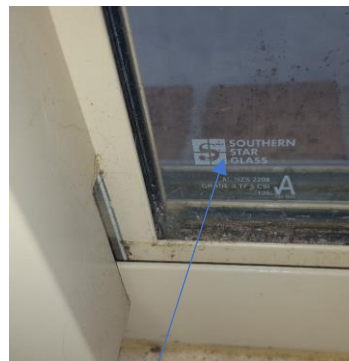
Single Low E safety glazing
